Manhole Inspection Summary

Manhole # S59K__003MH

Insp Date: **7/23/08 2:11 PM**

Location Address: **rear 646 s newkirk st**

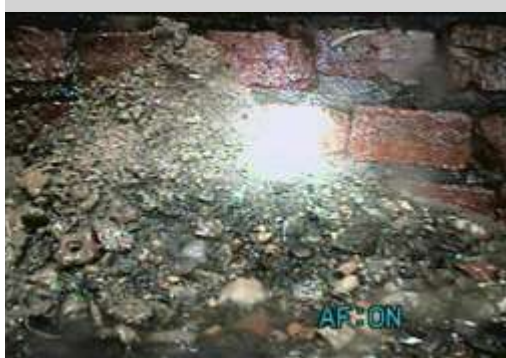
Miscellaneous

bench debris

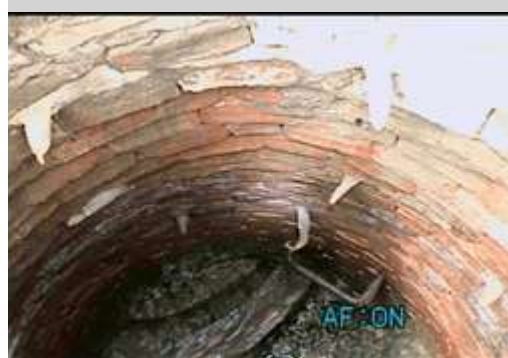
Defect 2

Count: **4** Missing: **3** ☐ Corroded

corroded and missing steps

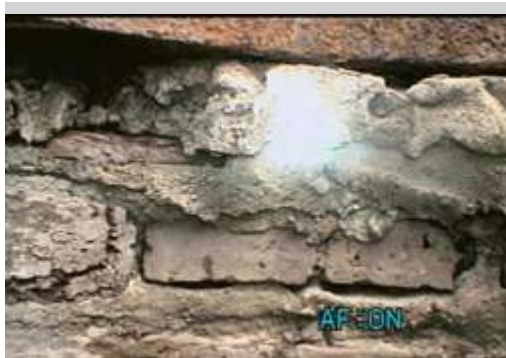
Defect 1

Condition: ☐ Sound ☐ Cracked ☐ Root Intrusion ☐ Loose Brick ☒ **Deteriorated**

frame adj; deteriorated chimney
